Fire Department Expansion Study

FINAL STUDY DOCUMENT

APRIL 3, 2023

CLEMSON UNIVERSITY FIRE STATION ADDITION

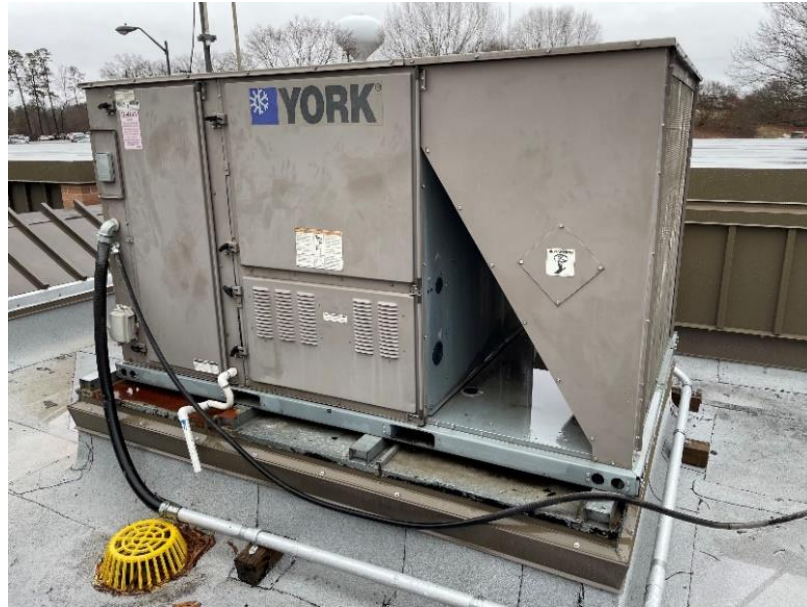
Figure 1: Packaged Heat Pump

The facility is served by a single 10-ton roof mounted packaged heat pump. The unit has been replaced and is approximately 7-10 years of age and in fair condition. Maintenance staff reported having a few issues in the past with the unit.

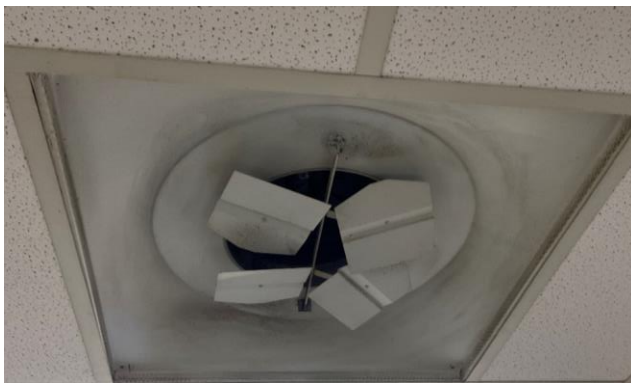
Figure 2: Supply Diffuser

The air distribution consists of sheetmetal ductwork with an external duct wrap, a series of lay-in ceiling mounted supply air grilles with a plenum return air system. The ductwork and insulation wrap is original construction and in fair condition. The ceiling mounted diffusers and grilles also appear original and are in poor condition. Staff indicated that many of the walls are not full height, and the plenum return creates a lot of “cross talk” among adjacent spaces.

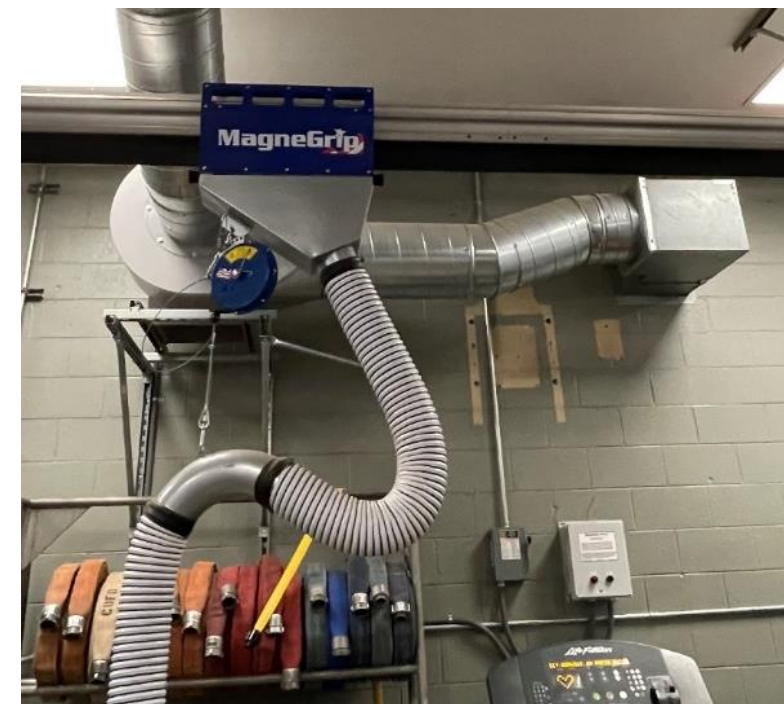
Figure 3: Vehicle Exhaust System

The rooftop unit is controlled by a wall mounted programmable thermostat in fair condition, it is not connected to a building automation system. Staff indicated there is no redundancy to the air conditioning system and requested some or all spaces have some sort of redundancy as the facility serves life safety purposes. From review of available roof space there does appear to be an opportunity to provide this redundancy. The facility has two toilet rooms that are served by ceiling mounted exhaust fans in poor condition. The fans are controlled by a wall switch that is interlocked with the space lights. The break room range is served by a light commercial range hood in fair condition. The apparatus bay is heated with approximately six electric unit heaters that are in fair to poor condition. A newer vehicle exhaust system with central fan and numerous hose drops serves the emergency vehicles while operating in the bay.

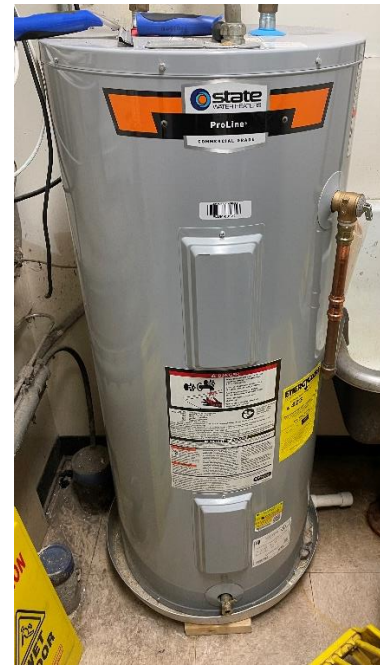
Figure 4: Water Heater

The facility is served by a 2-1/2" domestic cold-water line that enters the building in a closet adjacent to one of the restrooms. Maintenance staff reported that the domestic water lines throughout the facility needed to be replaced. The domestic water lines appear to be constructed of copper and are generally original construction. The piping is insulated with fiberglass and includes an all-service jacket that is generally in poor condition. Hot water is provided by a State (manufacturer) 40-gallon tank type water heater with 4.5 kW heating element. The water heater is newer and in good condition.

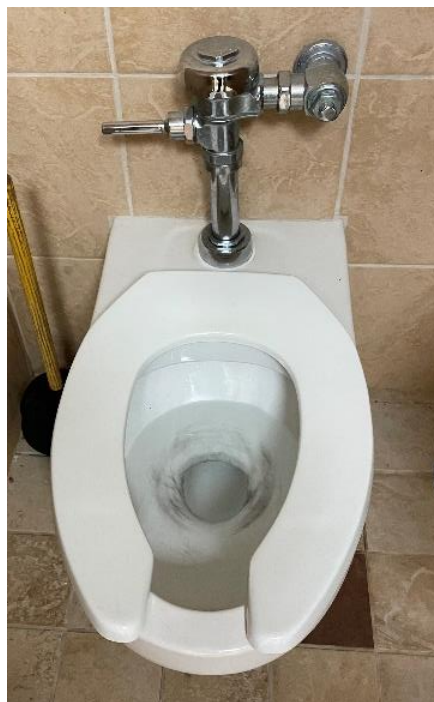
Figure 5: Water Closet

Staff requested some sort of redundancy in the hot water system. It was indicated that while the facility does not currently have a natural gas service a gas line is routed at the street and could potentially serve domestic water heating requirements. The water heater is installed in a janitor's closet adjacent to a pedestal mounted mop sink in poor condition. The janitor's closet does not include an exhaust fan and cannot contain the odors from cleaning equipment and solutions. Two gang toilet rooms (male and female) serve the facility that appear to have been renovated since the original construction. Lavatories are counter mount, with single level manual faucets and are in fair condition. Wall mounted shower heads and faucets serve each toilet room and are in fair condition. Water closets are floor mounted, white vitreous china and served with a manual flush valve. The male restroom includes wall mounted white vitreous china urinals served by manual flush valves. All flushing fixtures are in fair condition.

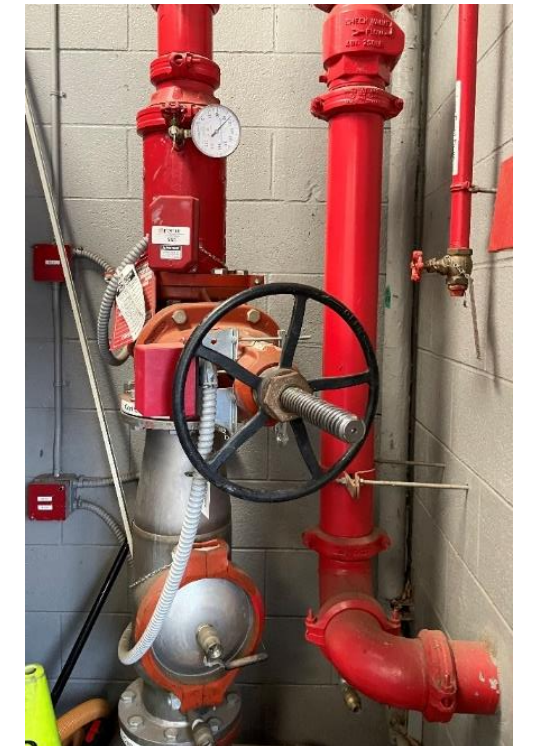
Figure 6: Fire Riser

A wet fire suppression system was installed to serve the facility approximately five years ago. The fire riser is installed within the apparatus bay and indicates good pressure from recent tests. The fire suppression riser includes a backflow preventer and serves upright sprinkler heads where exposed and ceiling mounted pendants in areas with lay-in ceilings. The sprinklers in the apparatus bay have guards preventing the accidental discharge of heads. The system is in fair to good condition.

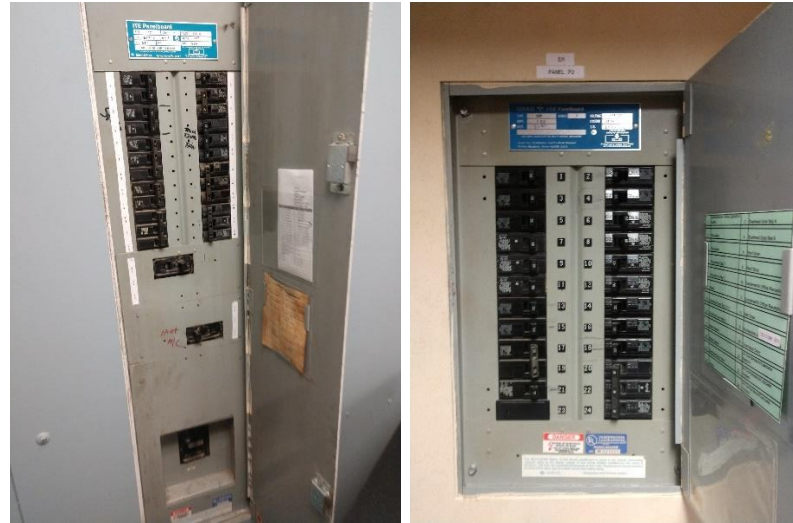
The electrical distribution system is **208Y/120-volt** system provided by a **pad mounted** transformer supplied by Clemson Electric. The main distribution equipment is a ITE 500A panelboard located in the hallway. The equipment was manufactured in 1980, is in poor condition and has no spare capacity. This equipment should be replaced. The main panel feeds an ITE 100A panelboard located in the office. The equipment was also manufactured in 1980, is in poor condition and has no spare capacity and should be replaced.

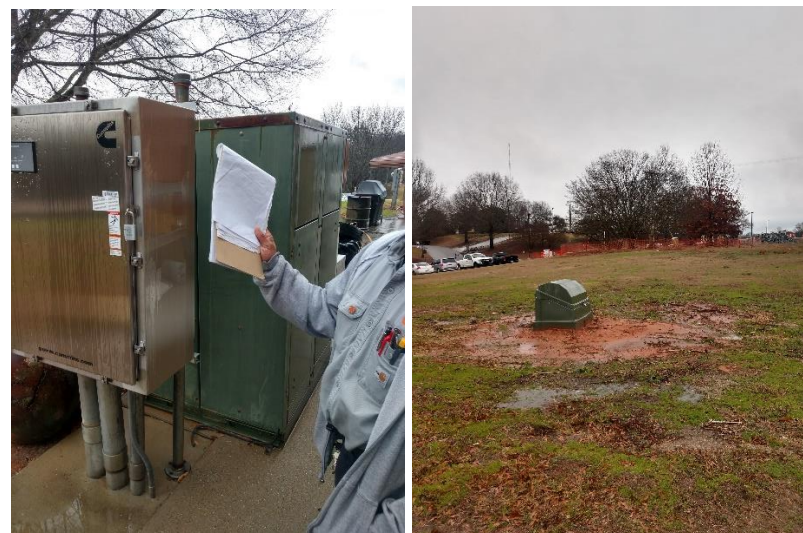
The existing pad mounted transformer is slated to be replaced by the university this year. It is suggested the replacement transformer be located such that will allow it to serve the new building as well. There is an existing splice between the road and the existing building that would be an ideal location.

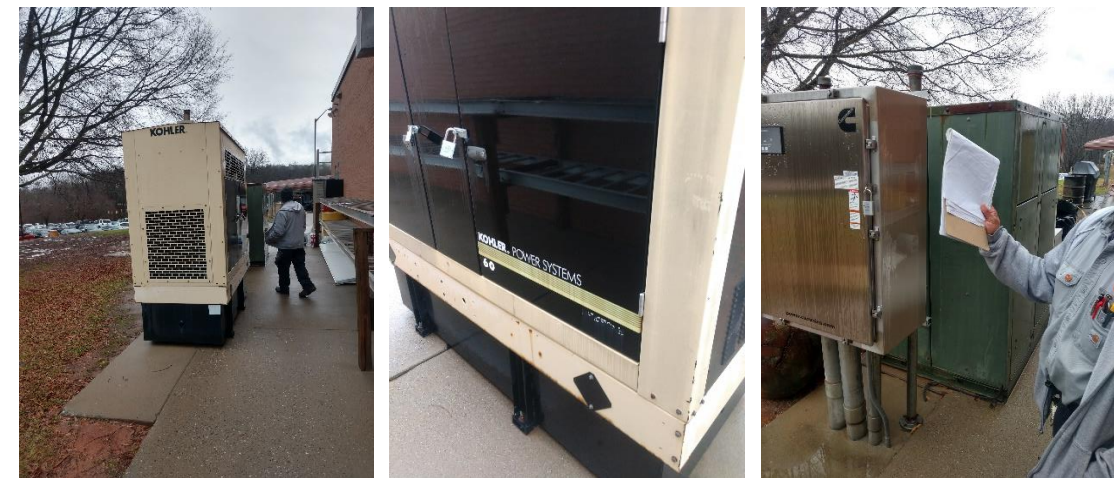
There is a Kohler 60KW/75 KVA, Diesel generator located outside the truck bay which serves the whole building. This equipment is approximately 6 years old, is in good condition, has spare capacity and could be retained, however the owner has requested a single generator to feed both the existing and new building

The generator is connected to the service by a 225A, Cummins automatic transfer switch. This equipment was recently replaced, in excellent condition, and therefore could be retained. However, this arrangement is not code compliant as emergency lighting and life safety loads must be in a separate ATS. This will be corrected in the renovation

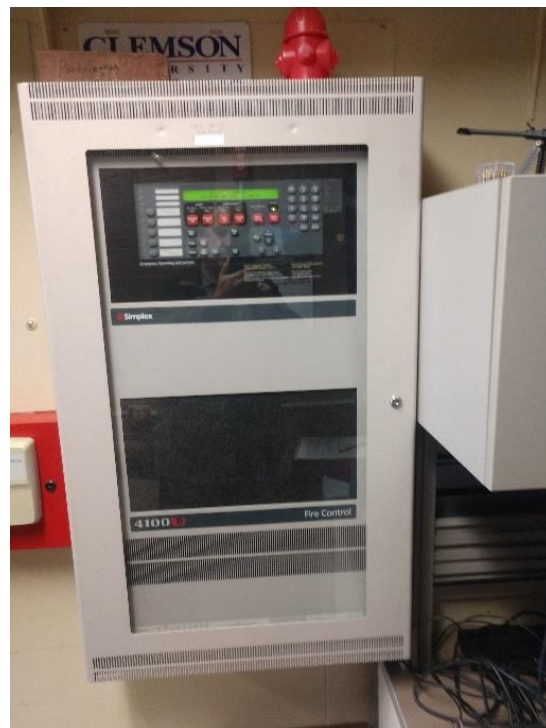
The fire alarm system is a Simplex 4100U, located in office, appears to be in good condition and could be retained however the owner has requested it be replaced. There are gaps in the coverage for detection and activation devices. This deficiency will be corrected during construction. The owner reports the sprinklers were added to the building approximately 6 years ago. The building still has the smoke detections require for an un-sprinklered building. These may be deleted in the renovation.

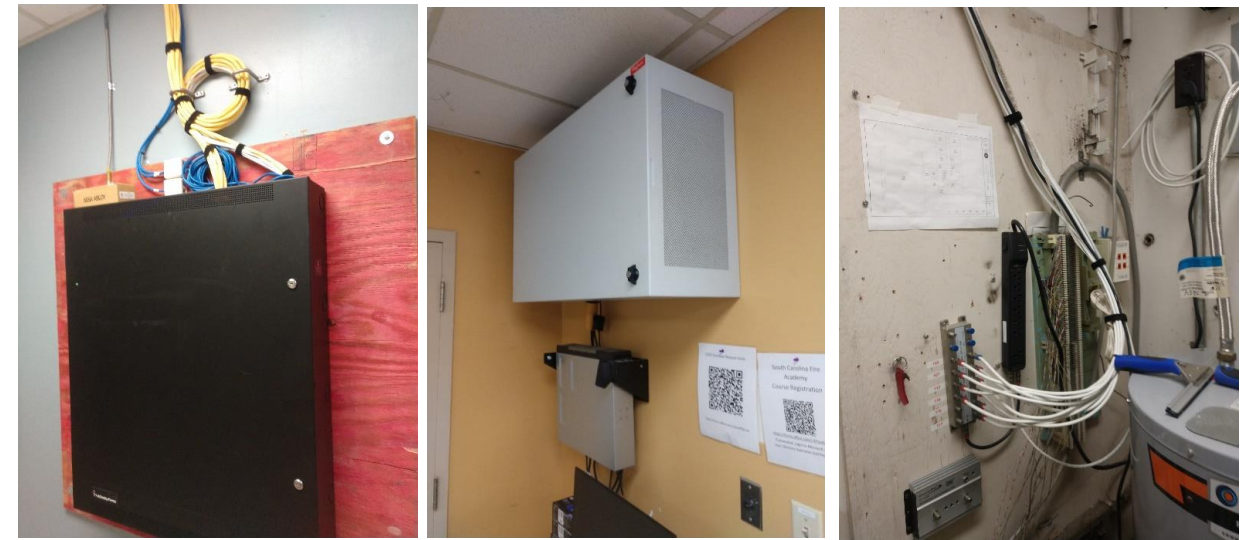
The telephone system demarks on a telephone board in the mech closet. A VoIP system is located in the meeting room system, appears to be in good condition and could be retained however it is not in an ideal location.

The data system is a collection of cabinet located in mech closet, appears to be in good condition and should be retained. The cabling is primarily Cat 5, cabling and is distributed in loose above the ceiling
