CLEMSON UNIVERSITY

PLAN AND GUIDELINES FOR RESTORATION, REHABILITATION AND MAINTENANCE OF HISTORIC RESOURCES

Clemson University
College of Architecture, Arts and Humanities
Department of Planning and Landscape Architecture
August, 1995

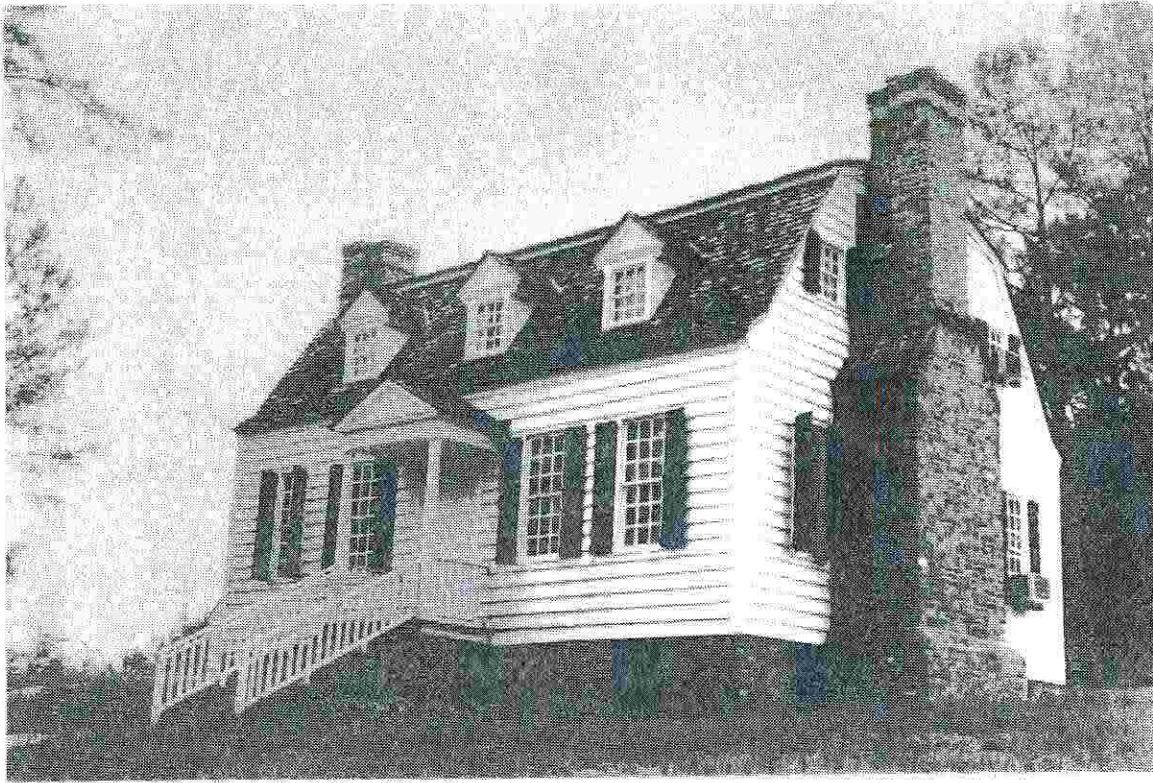
Existing wood shakes are thicker and wider than appropriate for the colonial period. They should be replaced with thin narrow wood shingles when the roof next needs major repairs.

A more formal axial entry with steps should be built to supplement the current curving sidewalk.

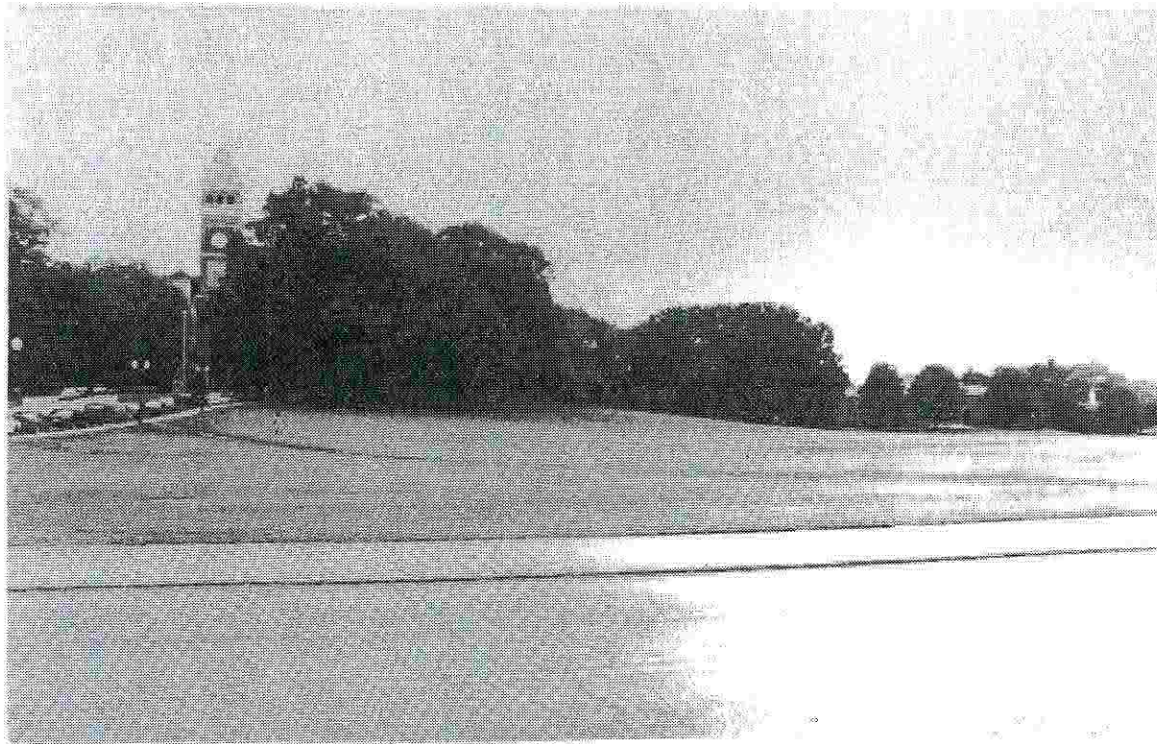
Figure 4: *Bowman Field serves to organize and relate the buildings of the early campus, including Tillman Hall, Sikes and Godfrey. It should be maintained as an open grassed field with no paved walkways or plazas other than the Mell Hall Plaza and the proposed military plaza.*

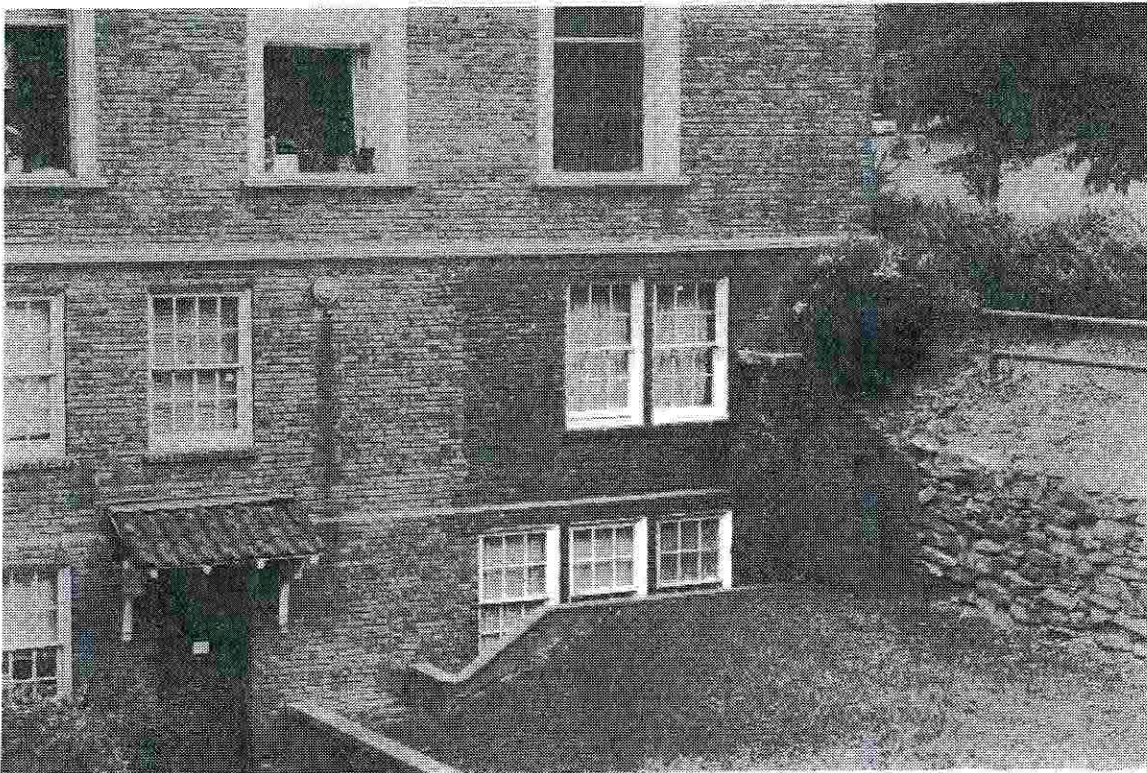
6. **Brickwork** is of mixed colors ranging from orange to almost purple. The bricks are mixed as they are laid to create a random effect. They should not be replaced by bricks that are uniform in color or that are of colors that do not match.

Figure 5: Non-matching brickwork at the YMCA detracts from the appearance of the south facade of the building.

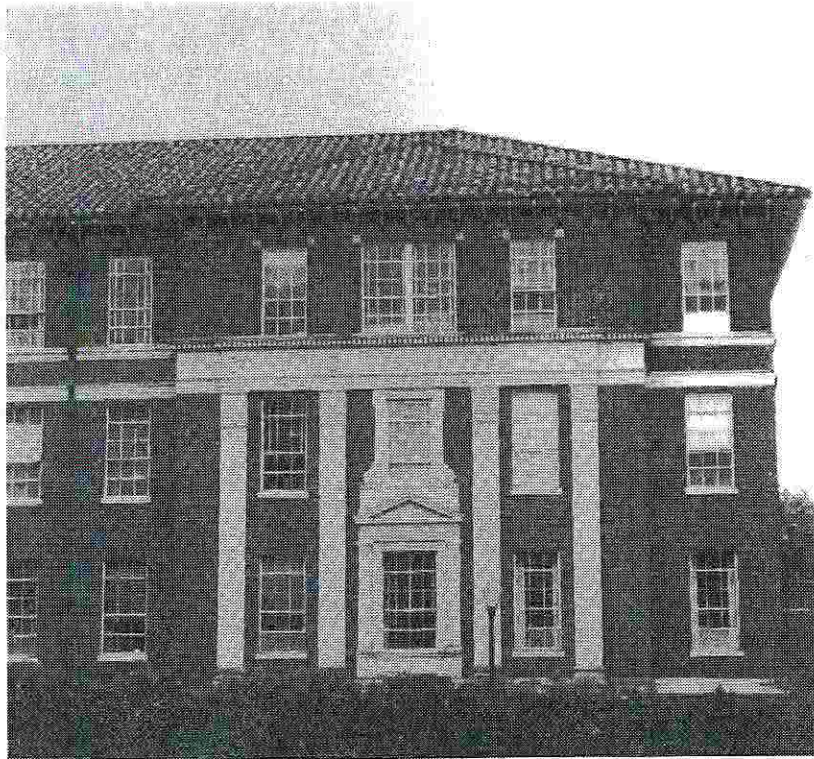
The key elements of Lee's buildings are illustrated below.

Hip Roof

Decorative Eaves & Brackets

Mosaics

1. **Roof lines** should not be altered. Hip roofs are a key defining characteristic of Lee buildings.
2. **Tile roofs** should be repaired with matching materials.
3. **Dormers** should be preserved, though variations may be allowed in louvered screens or windows in the ends of the dormers.

4. **Eaves and brackets** should be painted regularly to avoid deterioration that could lead to the need for replacement.

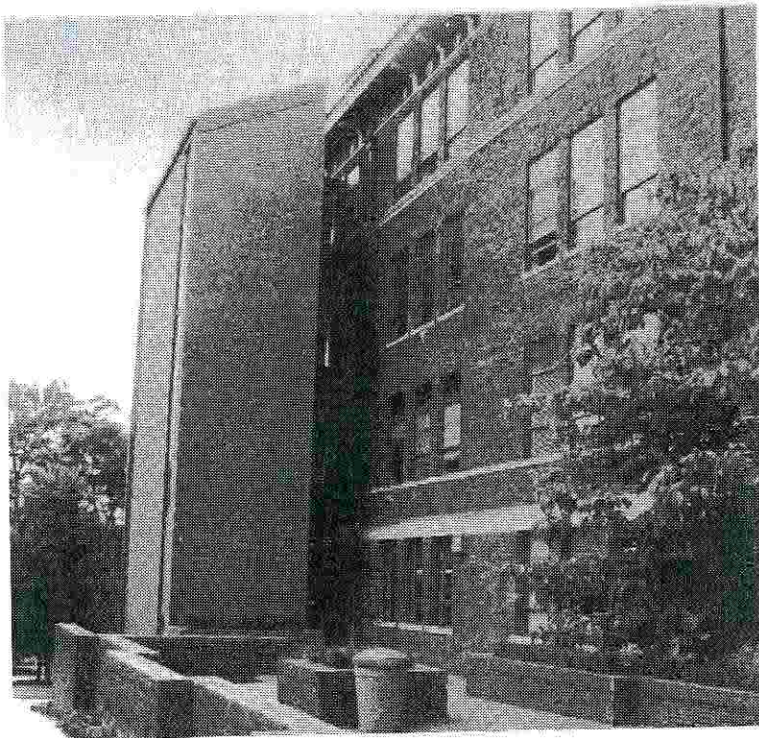
2. Stair and elevator towers at Sirrine Hall and Riggs Hall block the view of key facades and are incompatible with the symmetry, materials and details of the historic structures. The tower at Sirrine Hall is of monochrome brick, and does not respect the banding of the original structure. The roof is of non-matching materials. The tower should be relocated to the rear of the building adjacent to the Chemistry building, which already blocks the south facade of Sirrine Hall. Even on the rear, however, the new tower should reflect the banding and materials of the original building.

Figure 7: The Stair Tower at Sirrine Hall should be removed and replaced with a new stair tower located on the rear of the building adjacent to the chemistry building.

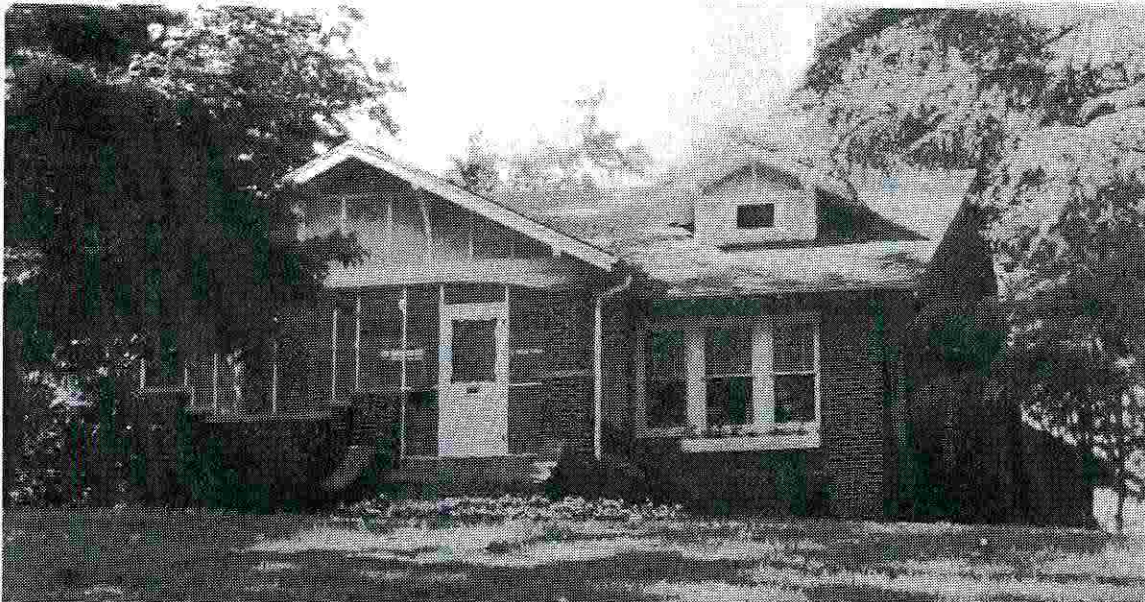
Figure 8: The Moorman House is one of the few remaining houses on Hotel Hill Road, long a major residential location for Clemson faculty. It should be maintained as a typical residential structure of the 1920's.

The Moorman House, one of the few remaining structures on Hotel Hill Road, should be treated as a local historic resource, and considered for nomination to the National Register in the future. It should be maintained to preserve its single-family residential character.

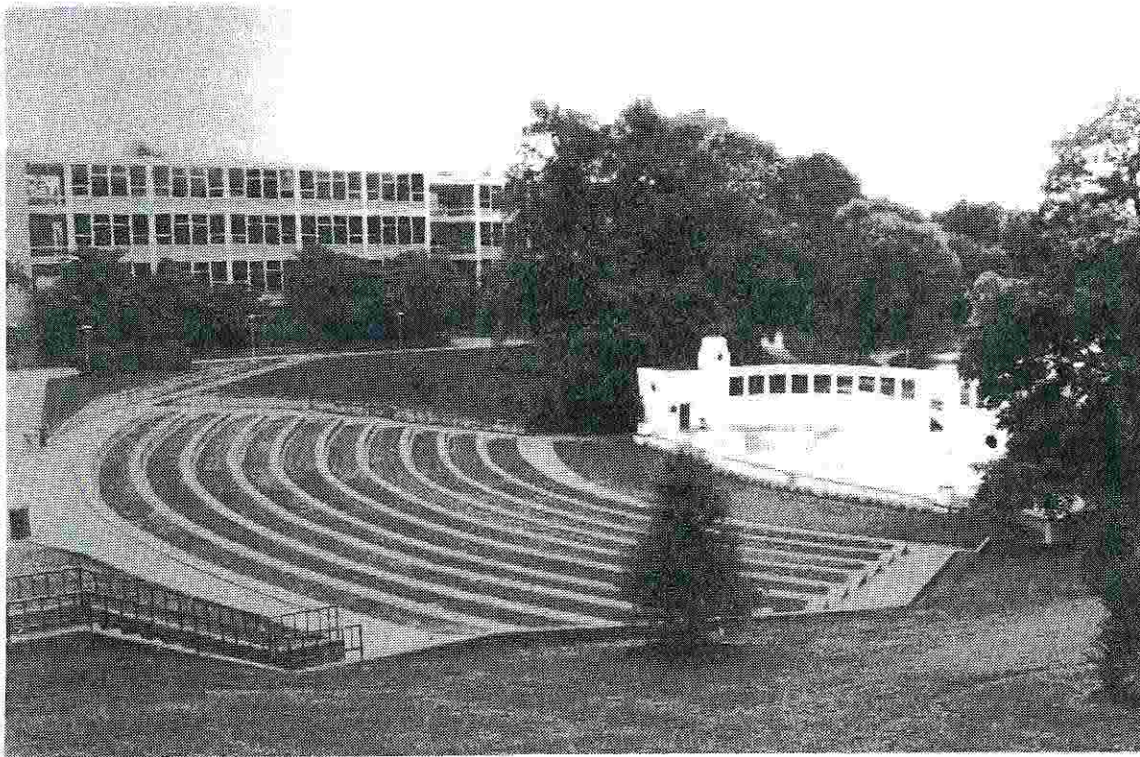
Figure 9: The Outdoor Theater, designed by Leon LeGrand, should be fully restored, and additional landscaping should be installed to screen off Martin Hall.

The outdoor theater is one of the few resources remaining from the 1940's. It should be screened from more modern additions, and its connection with Sikes and Hardin should be enhanced. Because the facility is deteriorating rapidly, it should be fully restored within five years based on a detailed restoration plan prepared by qualified consultants.

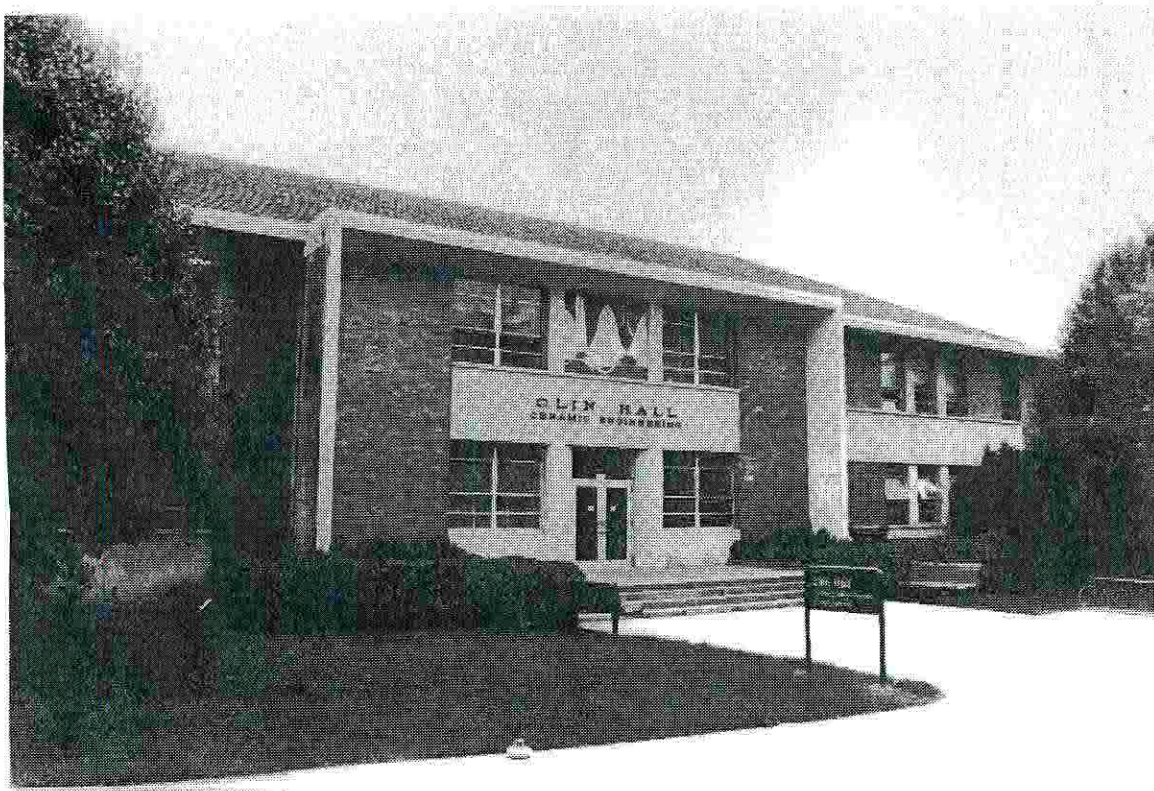
Figure 10: Olin Hall was built just after World War II and shares many design features of earlier campus buildings. Olin and Earle Halls should be reviewed for eligibility for nomination to the National Register.

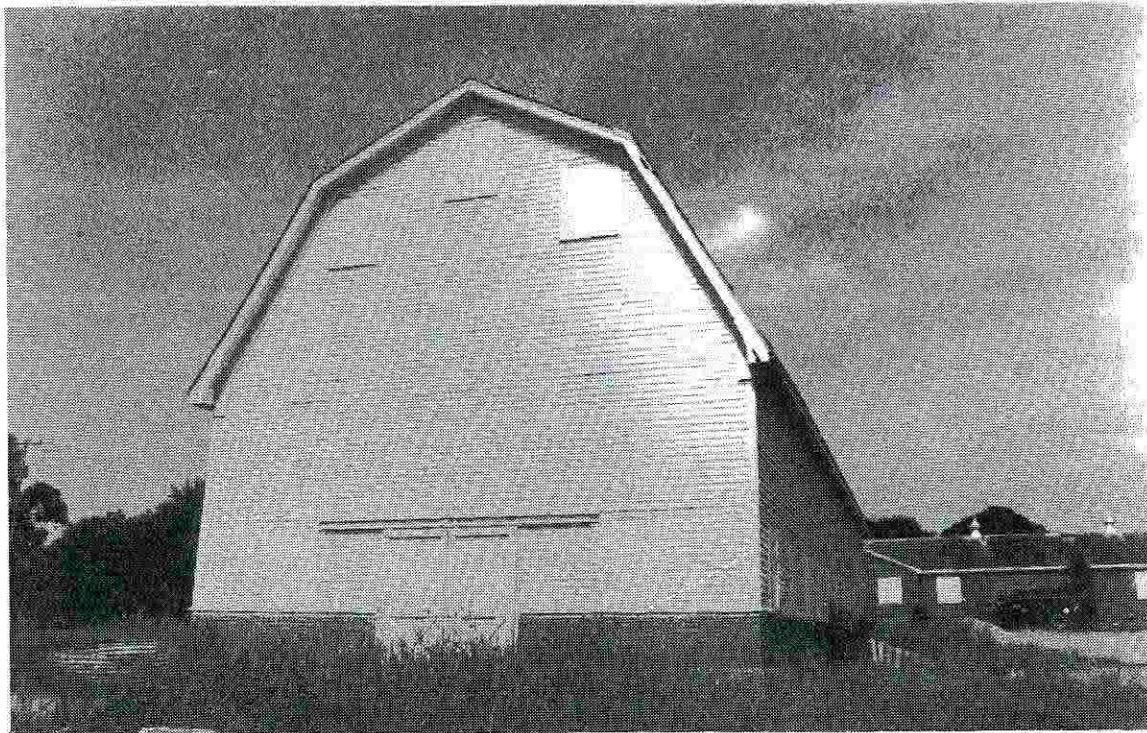
Figure 11: The Cattle Barn and the Dairy Barn are being used for construction activities and golf course maintenance, uses which are compatible with the design of the structures.

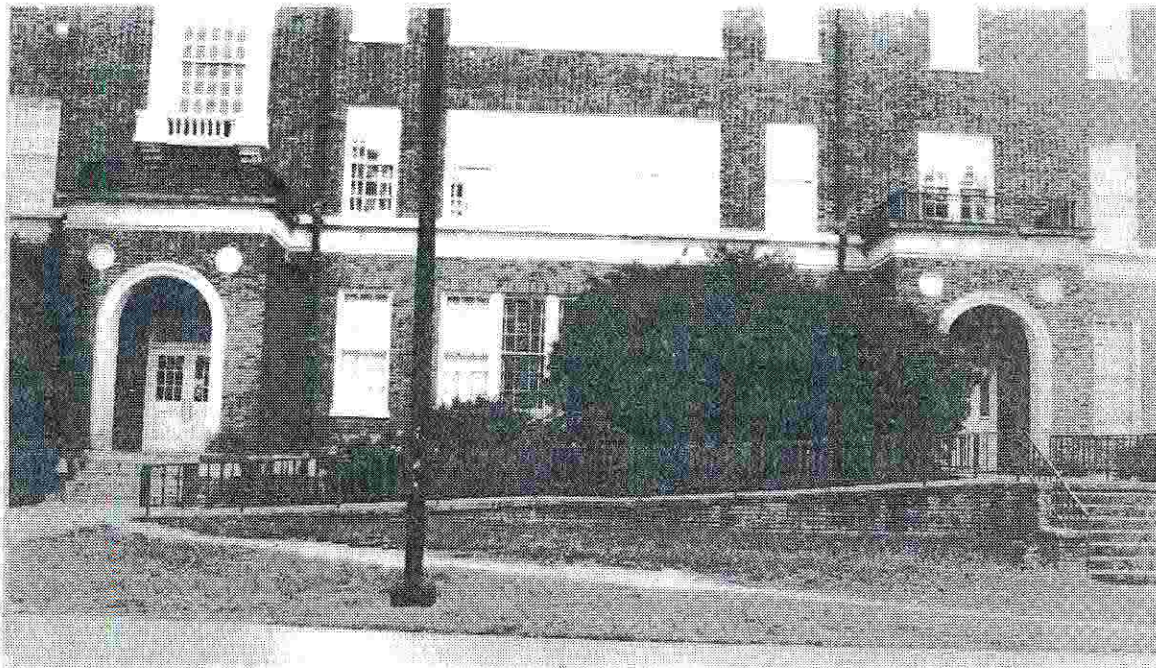
Figure 12: The handicapped ramp on the west side of Riggs Hall detracts from the symmetry of an important R. E. Lee building. It should be relocated or redesigned to be more compatible with the original design..

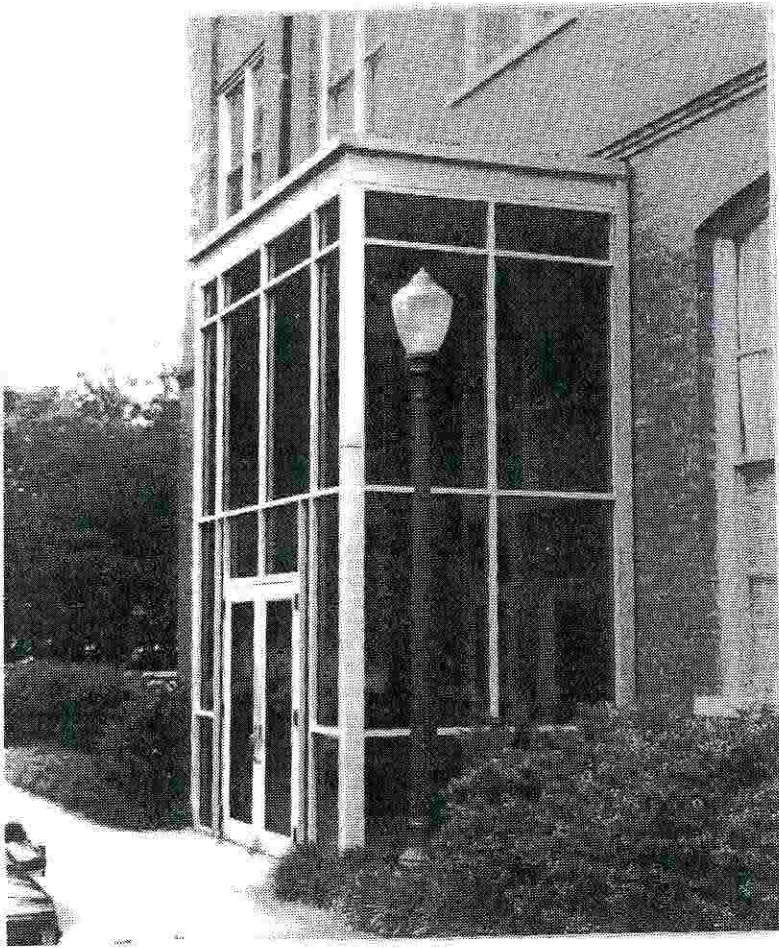
Air-lock entry units at Sikes Hall, especially the one in the rear, are functionally effective, but project outward from the facade. Interior air-locks are more sympathetic, and should be used wherever possible.

Figure 13: A glass and metal entry structure on the rear of Sikes Hall projects awkwardly from the facade. Interior air-locks should be used if possible.

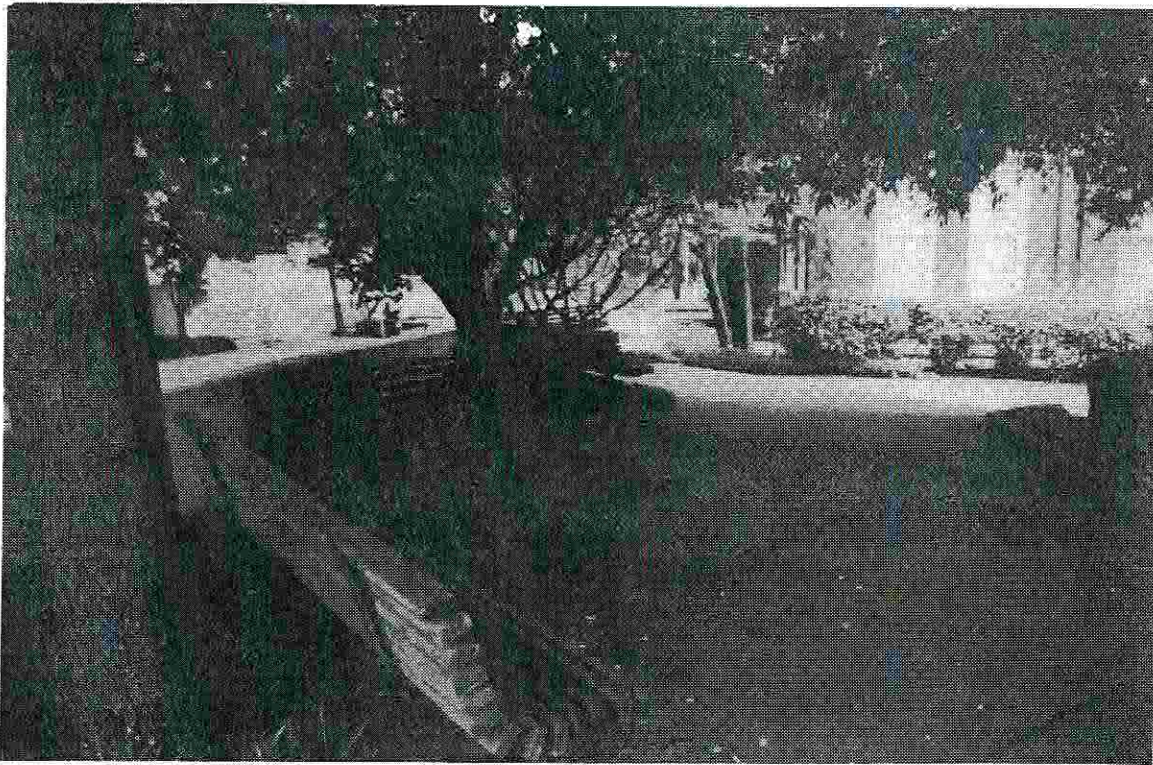
Even well designed functional landscape features can be inappropriate in the historic areas. The plaza northwest of Hardin Hall is much too urban in character to fit in the Tillman / Hardin / Riggs / Fort Hill quadrangle, and should be replaced with a simpler treatment. The Carillon Bell garden works with the formal axis of the outdoor theater and Cooper Library, but is too formal and structured to fit comfortably with Bowman Field and the critical Sikes - Tillman axis. Urban spaces, if they are used, should be placed only at the extreme edges of the historic area.

Figure 14: The seating area and plaza northeast of Hardin Hall is too formal and “urban” to fit comfortably in the Tillman-Hardin-Riggs-Fort Hill quadrangle. It should be redesigned to create a simpler and more open landscape.

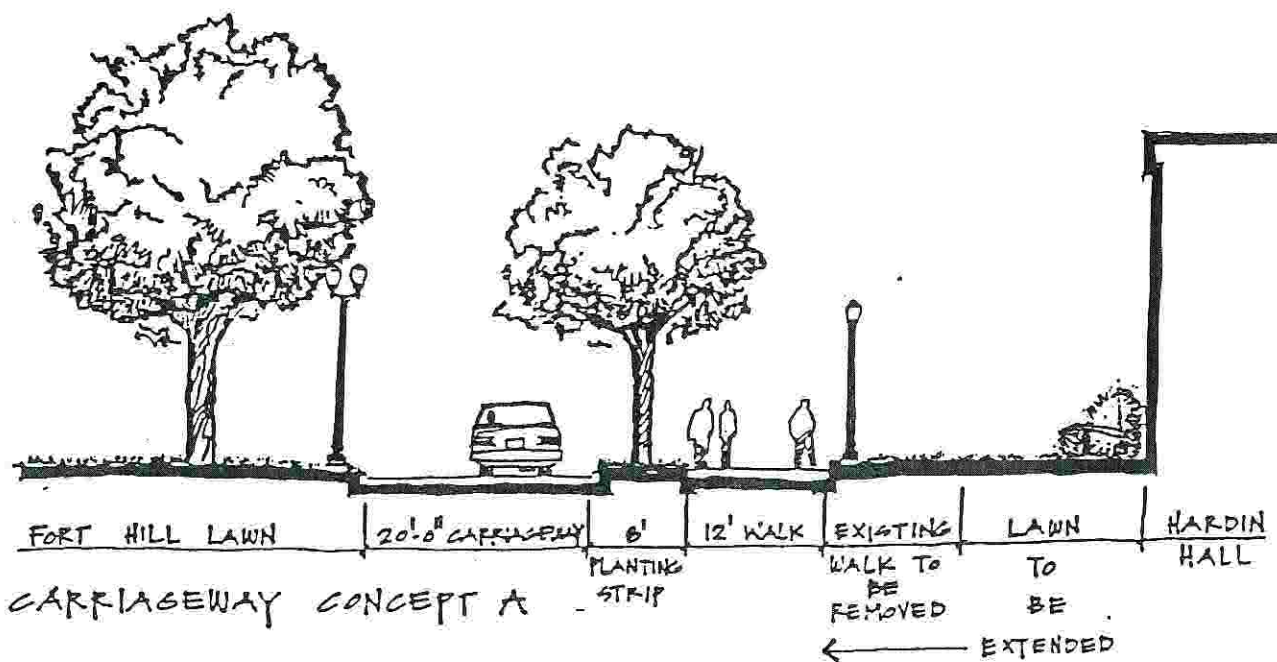
Figure 15: The Carriageway Concept, developed by Sasaki Associates in 1988, could improve the area near Hardin, Olin and Brackett Halls and could be extended by Riggs and Sistine Halls and down Fernow Street.

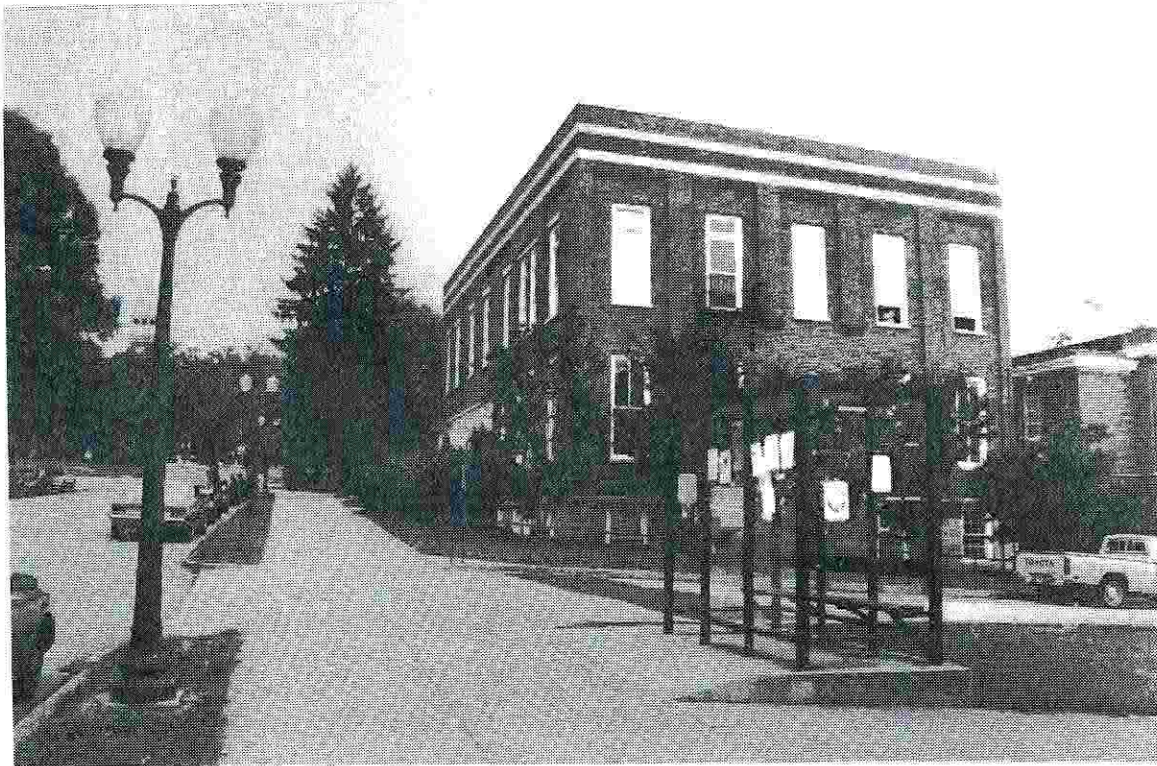
Despite its clean, open design, the bus shelter near Olin and Hardin Halls was considered by visual survey respondents to have a negative effect on historic character. If possible, it should be relocated to the opposite end of Olin Hall near the walkway to Cooper Library.

Figure 16: The Bus shelter at Olin and Hardin Halls is a simple structure, but was considered obtrusive in the visual survey. It could be relocated to the south end of Olin Hall near the walkway to Cooper Library. Maintenance should include removal of excessive flyers and notices taped to the glass panels.

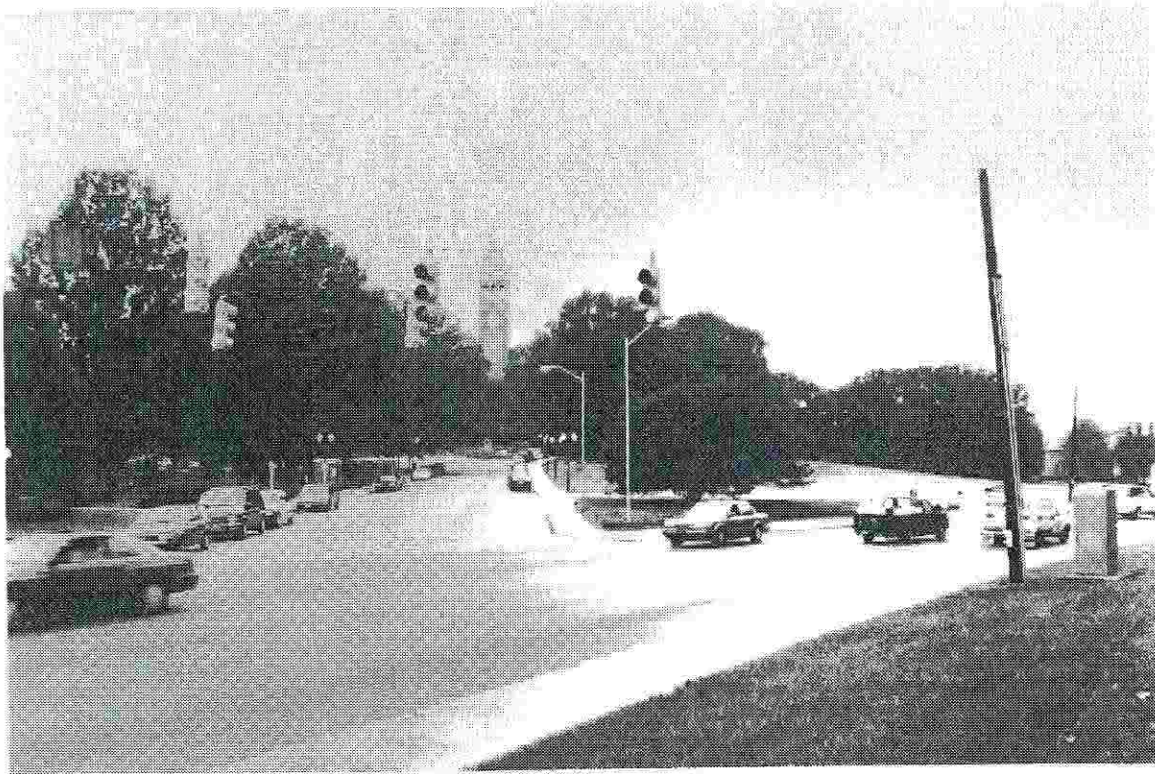
Existing traffic lights suspended from overhead wires near Sikes and Mell Halls partially block visitors' views into the historic campus and should be replaced with pole-arm structures in bronze or dark brown.

Figure 17: Traffic signals suspended from overhead wires near Bowman Field should be replaced with pole-arm fixtures in bronze or dark brown.

1. **Stoplights** suspended from overhead wires near Bowman Field should be removed and replaced with bronze-finish pole-arm fixtures. ISTEA funding could be sought for the project.

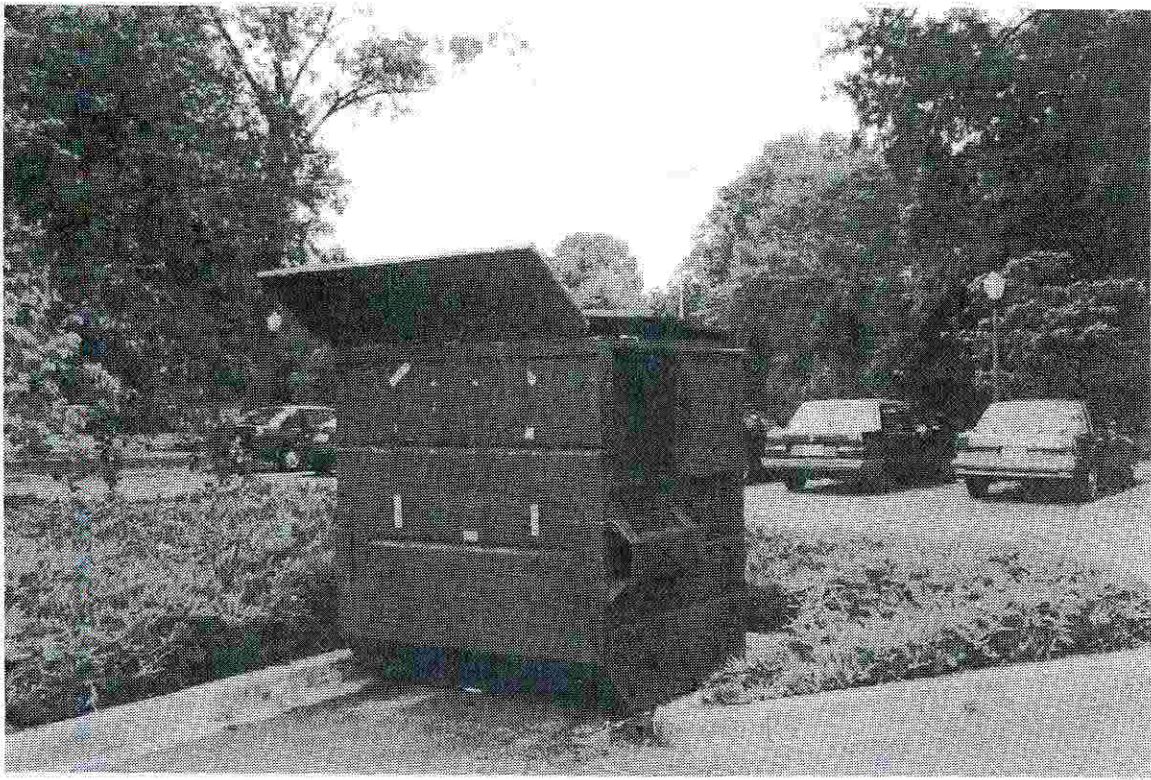
There are few dumpsters or other similar fixtures in the historic district. One dumpster is located behind Sikes Hall and is visible from Sikes, Long Hall, and SC 93. It should be relocated to a less conspicuous location or carefully enclosed in a wall or landscaping. A second dumpster in front of Fort Hill should also be relocated or enclosed.

Figure 18: Dumpsters, such as the one in the parking lot behind Sikes Hall, should be relocated or carefully screened by brick walls or landscape materials.

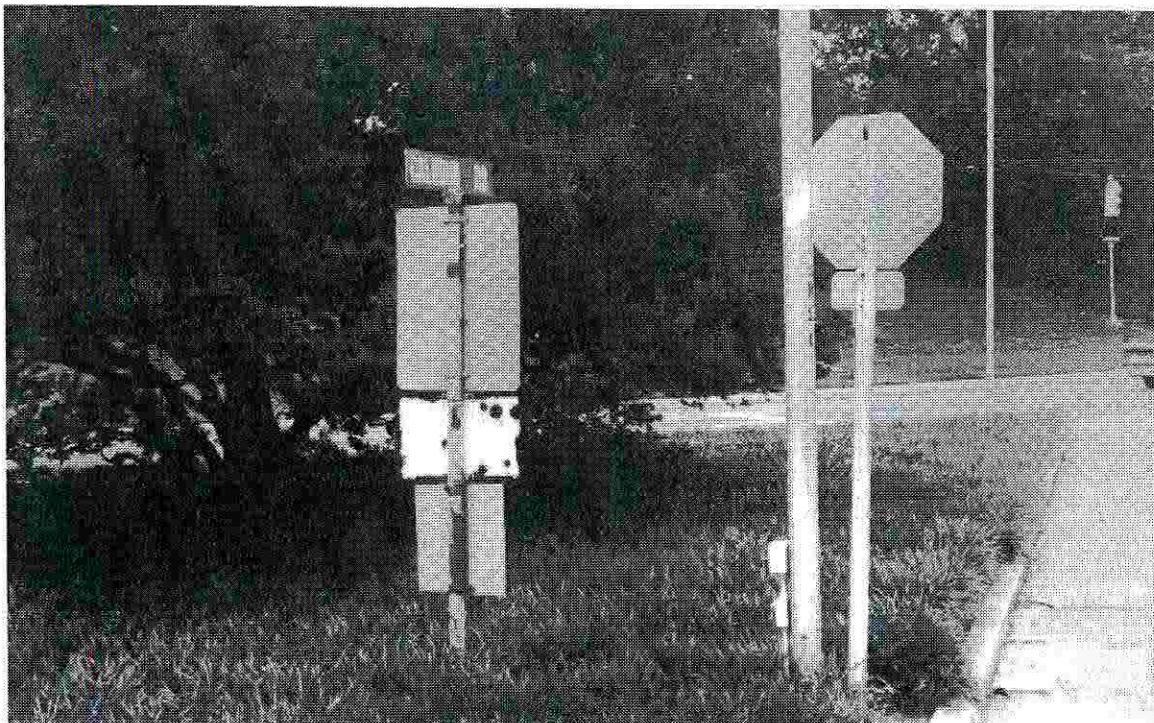
Traffic signs are limited in number, but are standard metal signs mounted on unpainted metal posts. Decorative cast iron fixtures are preferred, but existing signs could be improved by painting posts and sign backs bronze or brown to match campus signage.

Figure 19: Traffic signs, such as these in front of Sikes Hall, are unattractive, particularly from the rear. They should be replaced with decorative cast iron sign structures or be painted dark brown to match university signage.

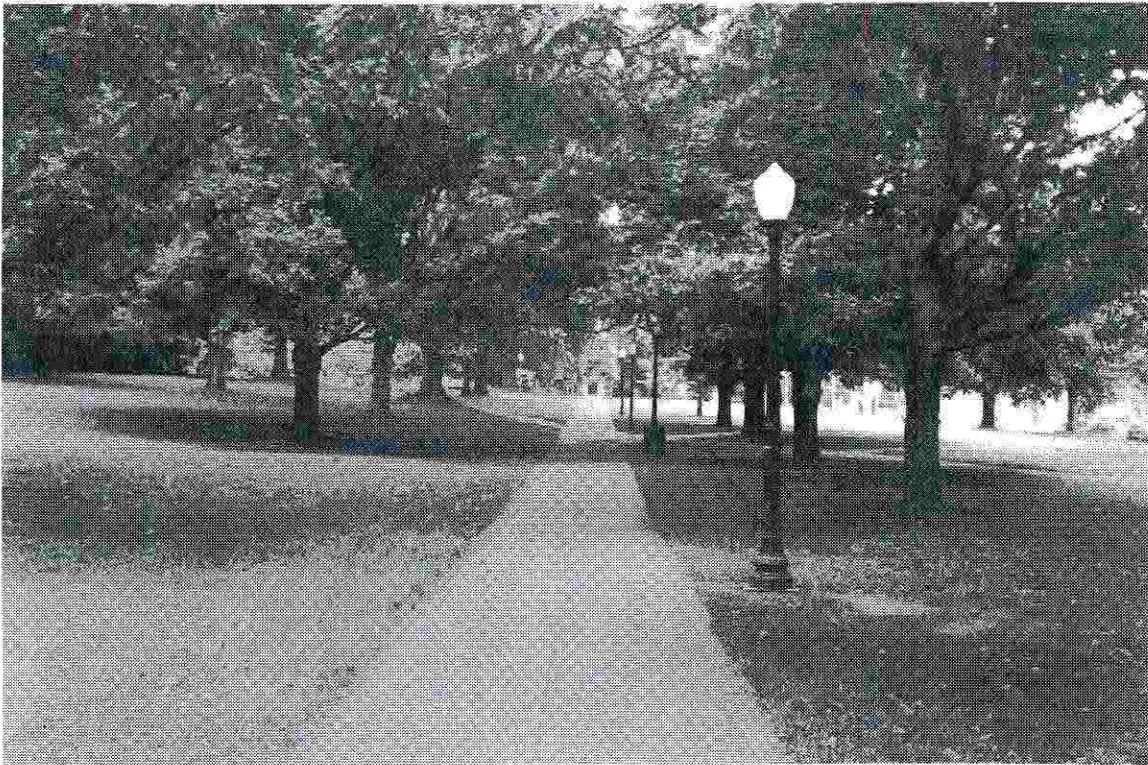
The tree lined allee from Tillman Hall to Riggs Hall helps define the historic relationship between the buildings and should be preserved.

Figure 20: The allee of trees between Tillman Hall and Riggs Hall is an important landscape feature that should be preserved in its own right.

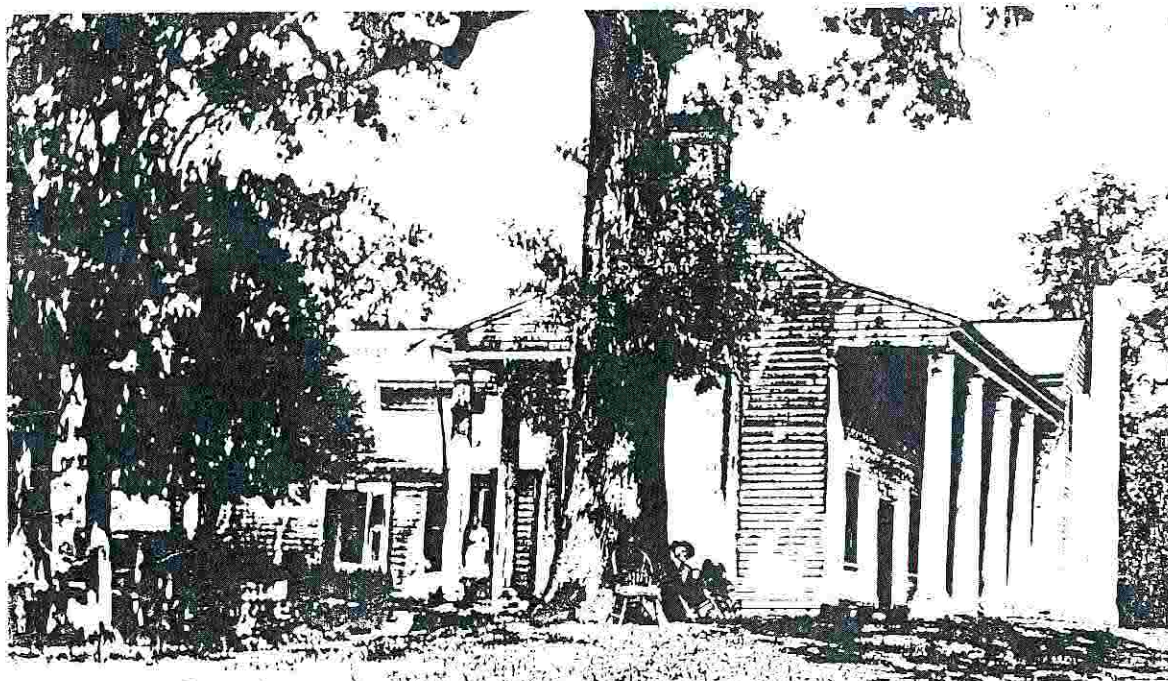
Landscaping at Fort Hill should be documented and dated back to the era of John C. Calhoun and Thomas Green Clemson. Rows of eastern Red Cedars (*Juniperus virginiana*), for example, once extended down both sides of present day Fernow Street. Remaining trees should be preserved, and missing trees should be replaced.

Figure 21: Fort Hill in the time of Thomas Green Clemson (seated in front of the house) was much more informal and open than it is now.
