Fire Department Expansion Study

FINAL STUDY DOCUMENT

APRIL 3, 2023

CLEMSON UNIVERSITY FIRE STATION ADDITION

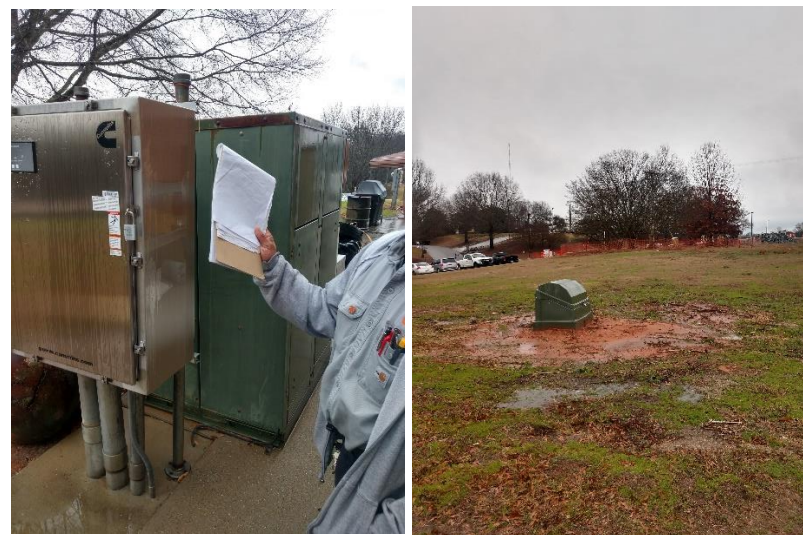
Generator

There is a Kohler 60KW/75 KVA, Diesel generator located outside the truck bay which serves the whole building. This equipment is approximately 6 years old, is in good condition, has spare capacity and could be retained, however the owner has requested a single generator to feed both the existing and new building
