SPACE UTILIZATION STUDY

2002

OVERVIEW

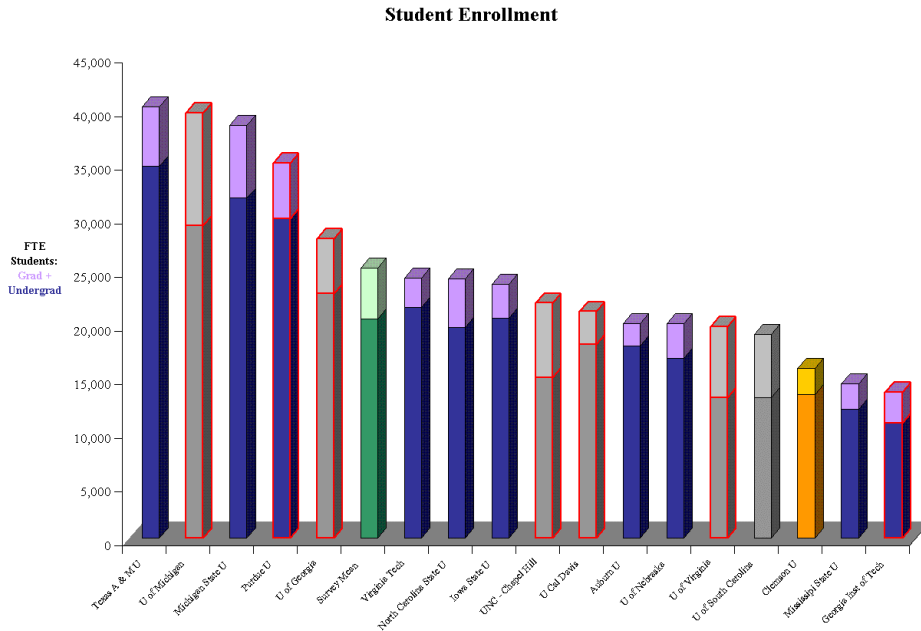
Graph 2: Student Enrollment

The highest enrollment in the peer comparison was Texas A & M with over 40,000 students. The mean was 25,200 and Clemson’s enrollment was 15,800. The number of FTE faculty at Clemson was 960 while the mean was 1,450. The number of faculty at the University of Michigan, at 3,400, is well above the others.

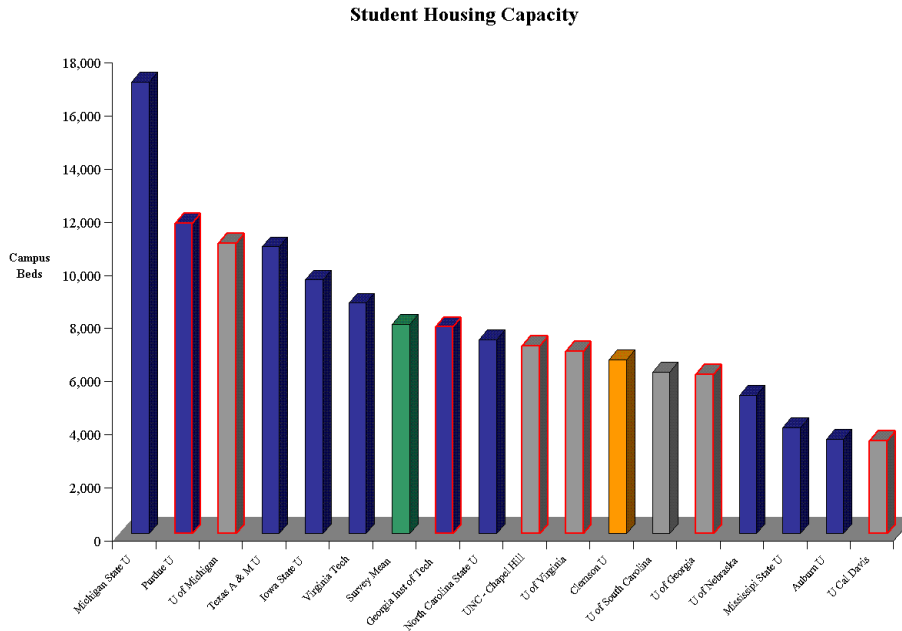
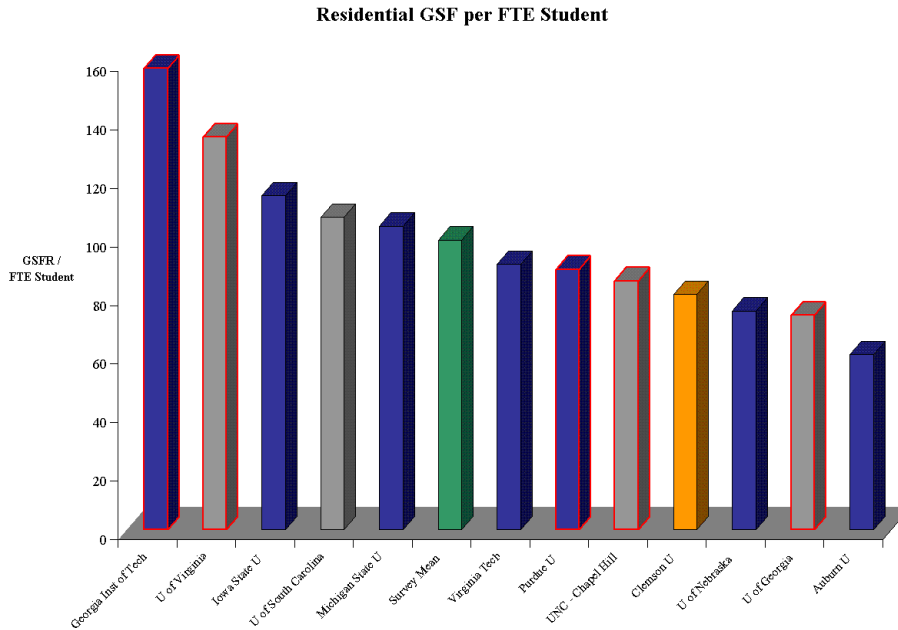
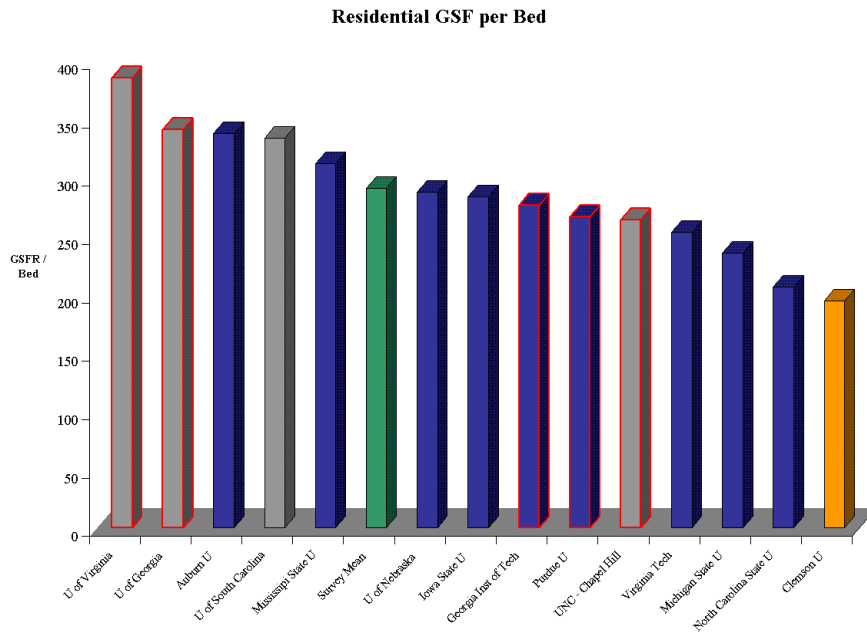
The need for housing on a campus is determined by program, although it is also affected by a number of other institutional characteristics, including the availability of appropriate housing off campus, commuter versus residential campus, strength of the Greek system, and the quality of existing on-campus housing. These factors must be considered in interpreting peer comparisons. Clemson provides 6,540 beds which is fairly close to the survey mean of 7,900 beds. There are 80 GSF of residential space per student at Clemson, which is close to the mean of 95 GSF. The amount of space per bed at Clemson is low, and 96 GSF less than the mean of 291 GSF.

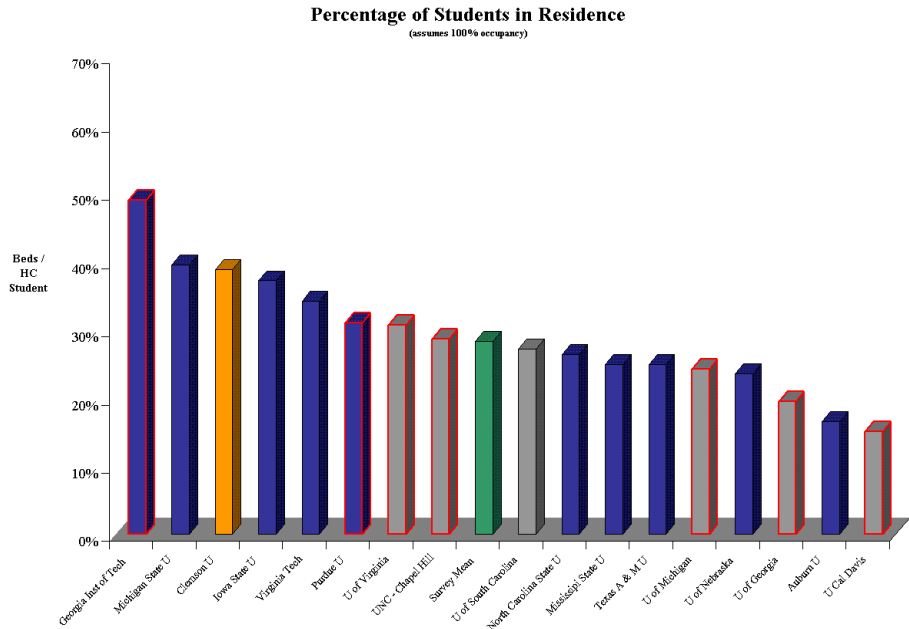
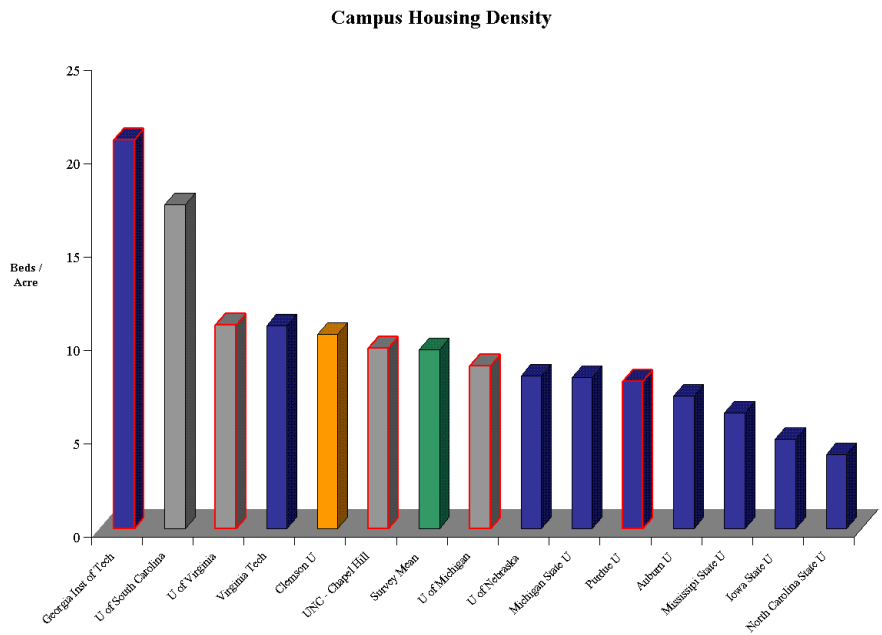
Clemson has a higher percentage of its students living on campus than the average of its peers. Approximately 40 percent of Clemson students live on campus. This is considerably higher than the mean of 28 percent. So although more students than average live on campus, the amount of space per student is low. The density or beds per acres, is shown on Graph 15. There is a wide range of from 4 to 21 beds per acre. The mean is 10 and Clemson is slightly over.

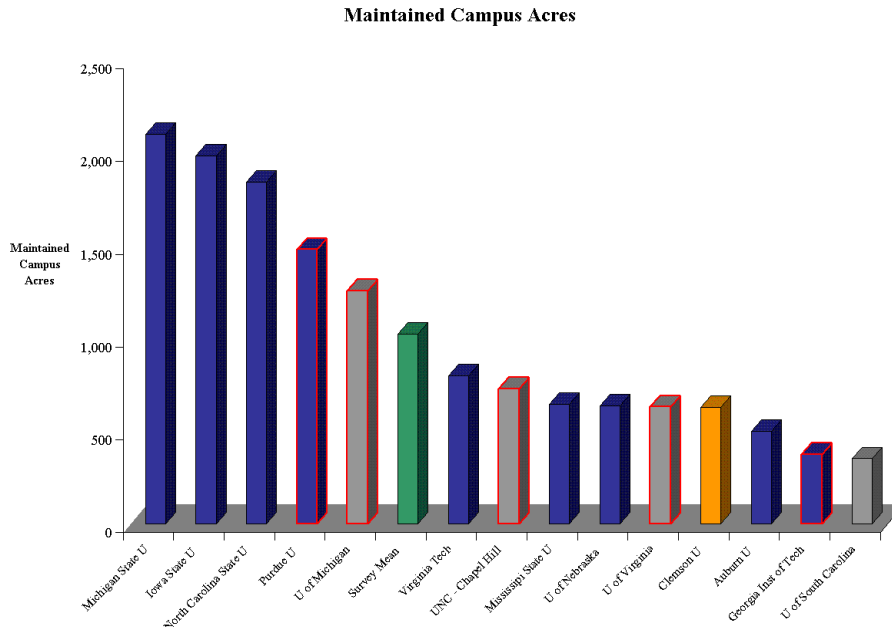
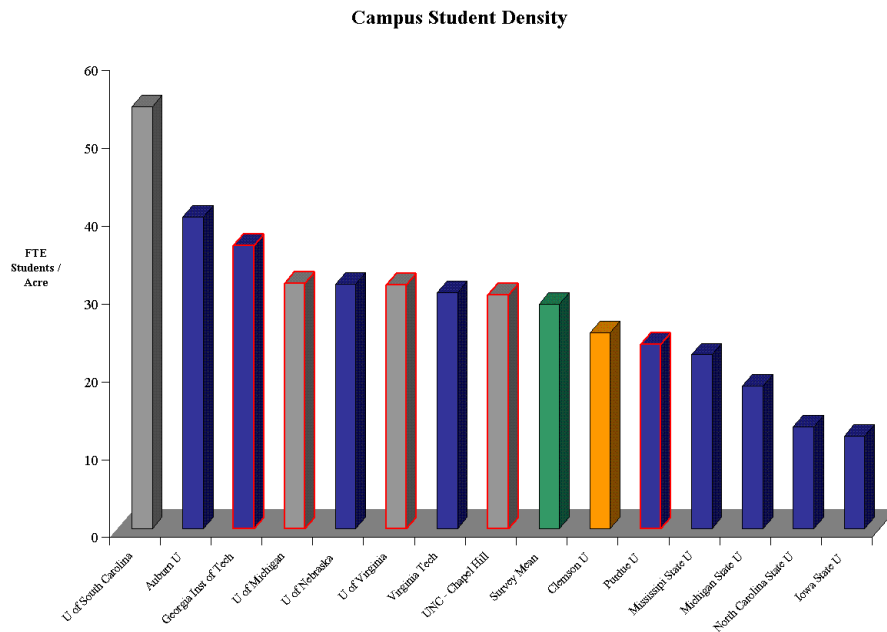
The maintained 628 acres at Clemson is on the low end of the comparison. See Graph 16. The lowest is 350 acres, the highest is 2,100, and the mean is 1,000. More important, however, is the Number of students per acre. Here Clemson is at 25 acres and the mean is 29 FTE students per acre.

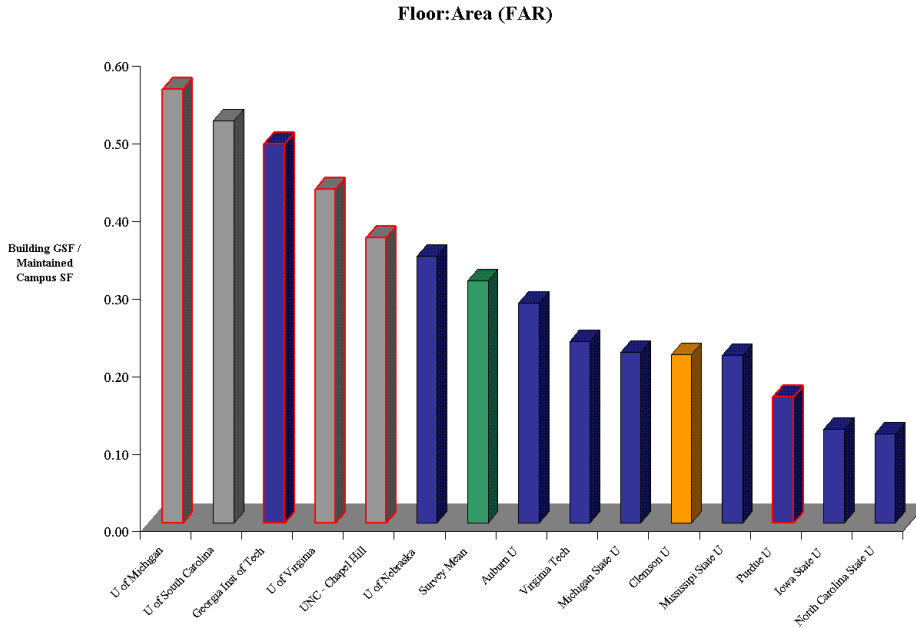
Graph 18: FAR

The floor area ratio (FAR), or GSF per maintained campus square foot, is another indicator of the density of a campus. Clemson is .22 GSF per maintained square foot, which is between the low end at .12 and the mean at .31.

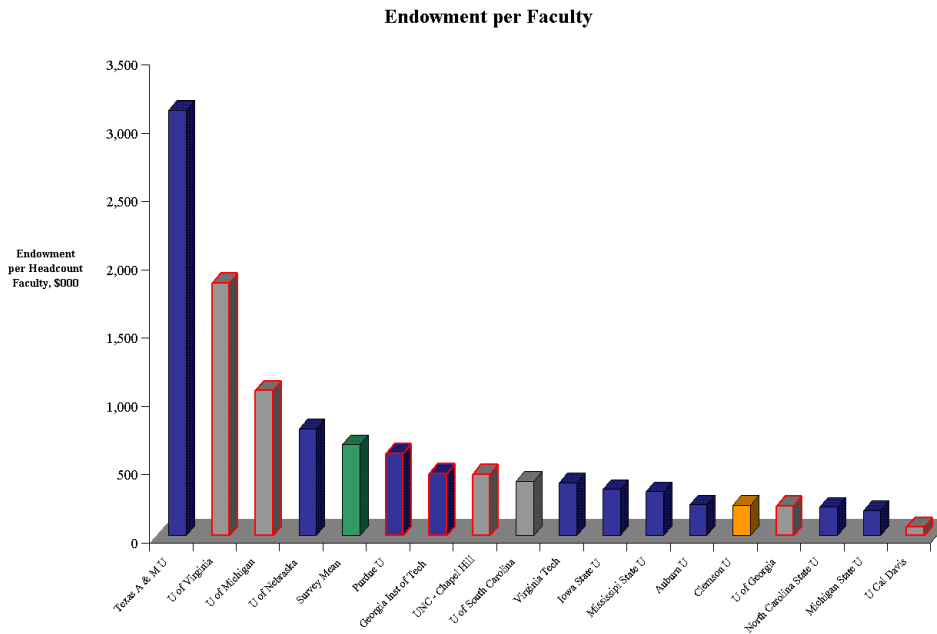
Graph 21: Endowment/Faculty

Graph 21 compares endowment per faculty. At about \$223,000 per faculty, Clemson’s endowment is about a third of the mean. In this comparison, Texas A & M is well above the others, raising the mean.
